Europe District surveys earthquake damage in Turkey

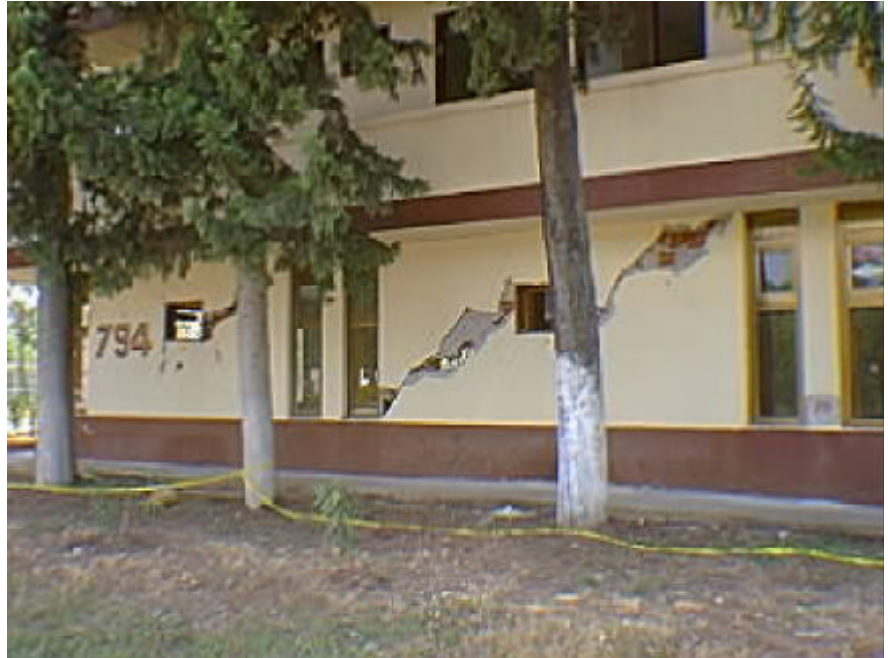
The Turkish Base Exchange on Incirlik Air Base in Turkey was damaged in the June 27 earthquake. A team of engineers from Europe District recently evaluated structural damage to buildings on the base caused by the quake.
(Photo by Gordon Simmons)

The base exchange sustained a fair amount of damage, according to Baxter, which required the quick development of a JOC delivery order so repairs could be made.

“The walls surrounding the Power Zone were severely damaged and the area was determined unsafe,” said Baxter. “The interior wall behind the shoe store across the entire width of the base exchange was unstable. We installed a temporary wall

so the facility could be opened and still be safe for the public. The temporary wall allowed the contractor to perform demolition and install new walls at a later date.”
